# AILS WORTH CONSERVATION AREA APPRAISAL REPORT AND MANAGEMENT PLAN

**Prepared by:** Planning and Delivery, Peterborough City Council

**Date:** March 2009

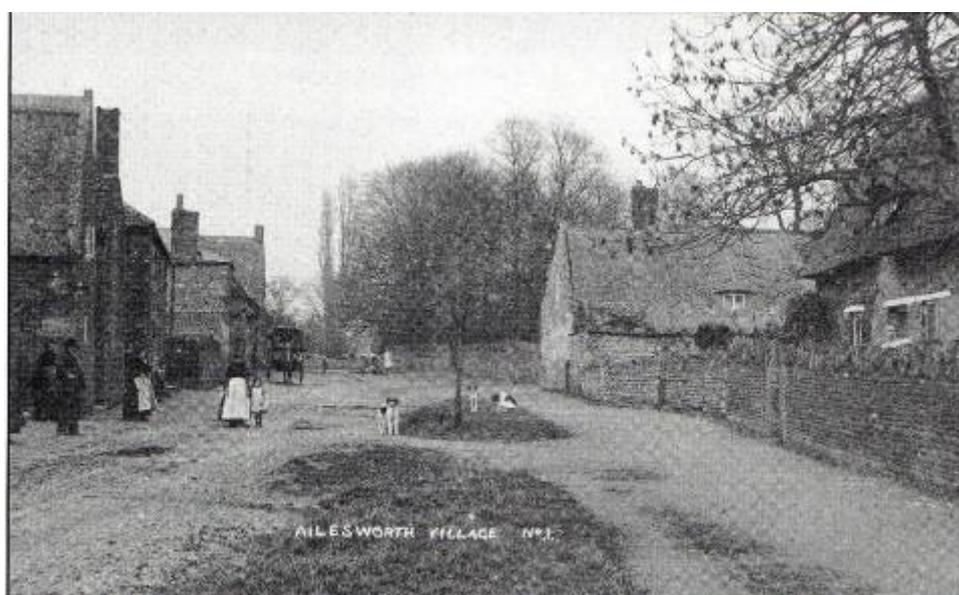
*Main Street 1900*

In the photograph on page 8, the right hand frontage shows the pre 1800 village of stone and thatch cottages, spaced along the road, in their own plots with stone walls to the frontages between. The left frontage appears to have been in-filled with 19th century cottages. The roads are un-metalled, without pavements or street lights. The trees are to the frontage of Manor Farm and at the end of Main Street can be identified on the historic OS map and still exist today. It appears that the village pump is in the centre grass verge, between the dogs.

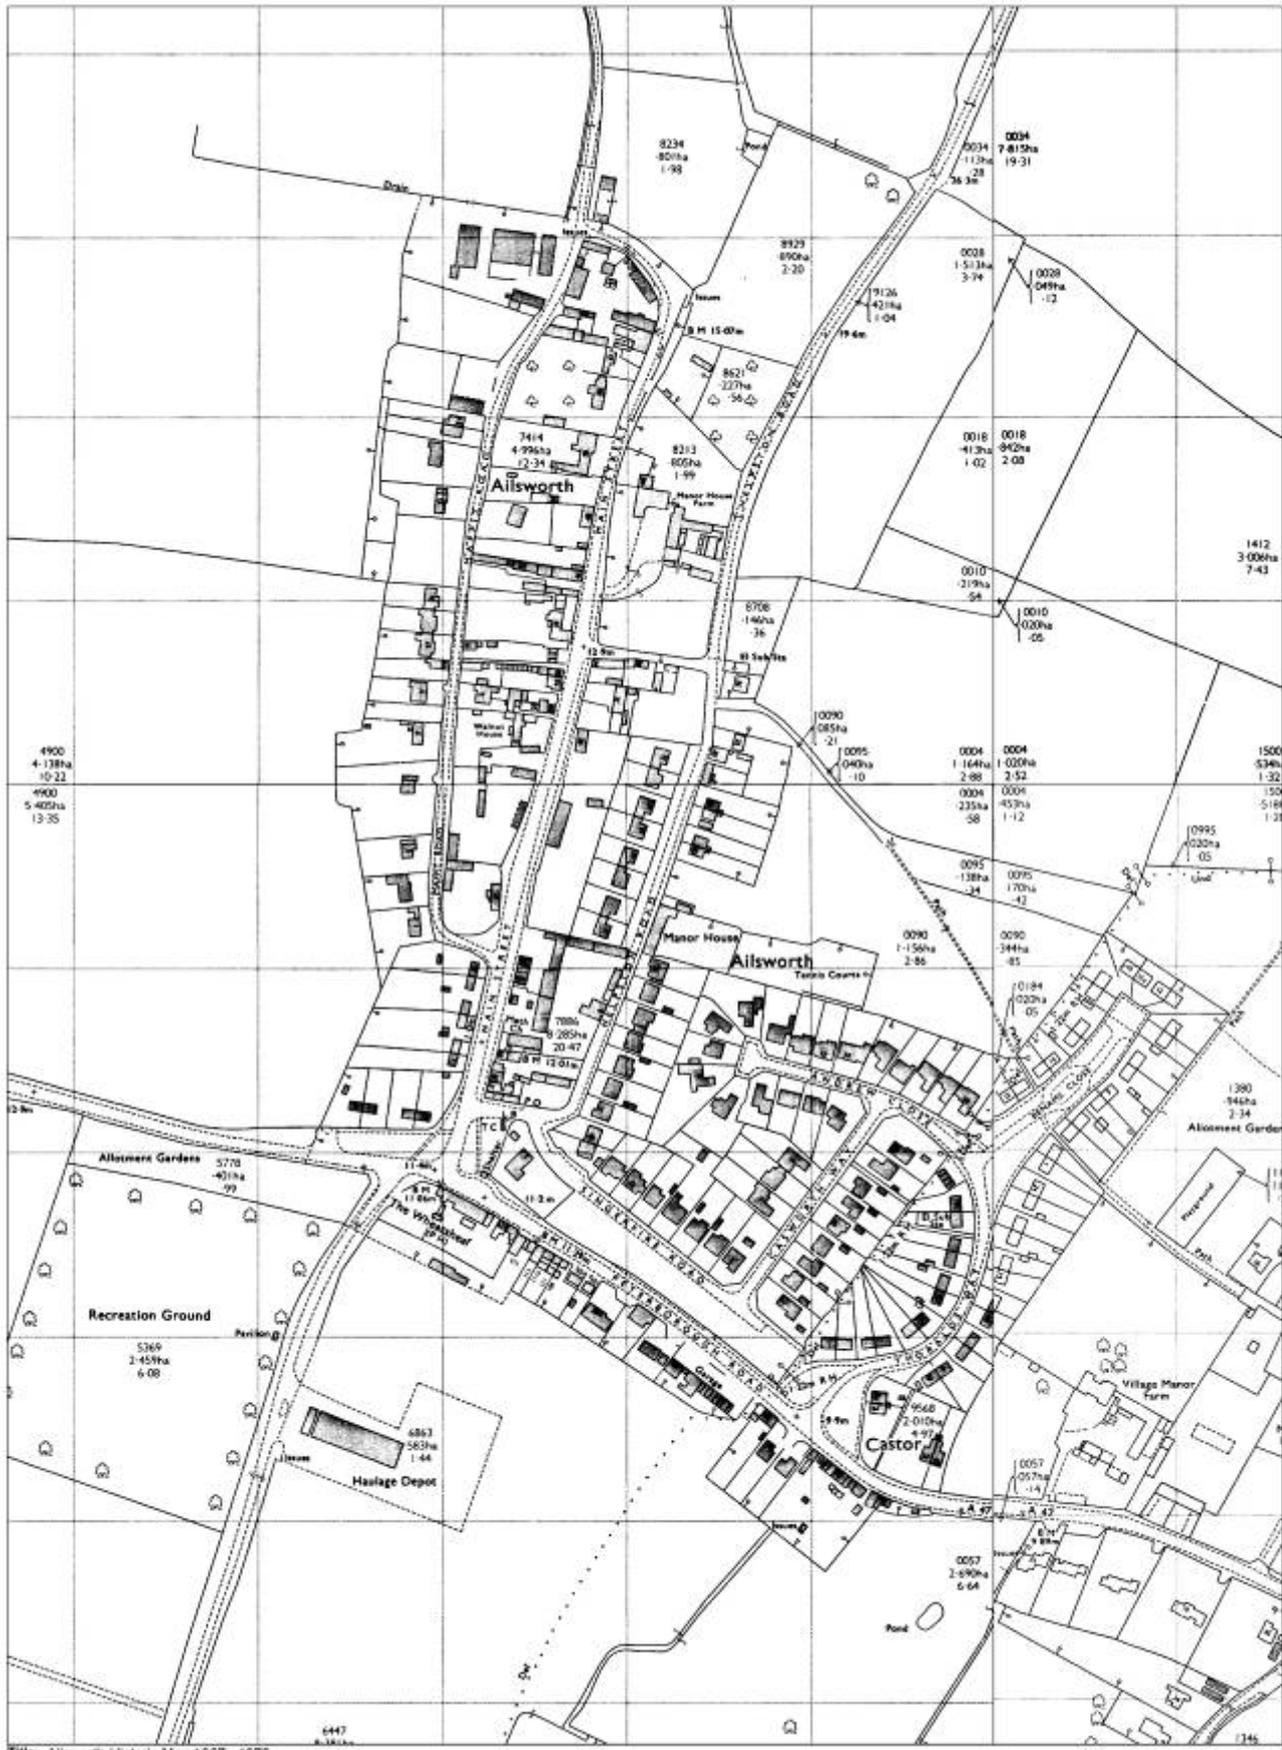
Map 5 Ordnance Survey 1967

Title Ailsworth Historic Map 1967 - 1976  
 Department Planning Services Drg. No. N/A PCC GIS  
 Scale 1:2500 Date 12th November 2007 Name LRM  
 Peterborough City Council

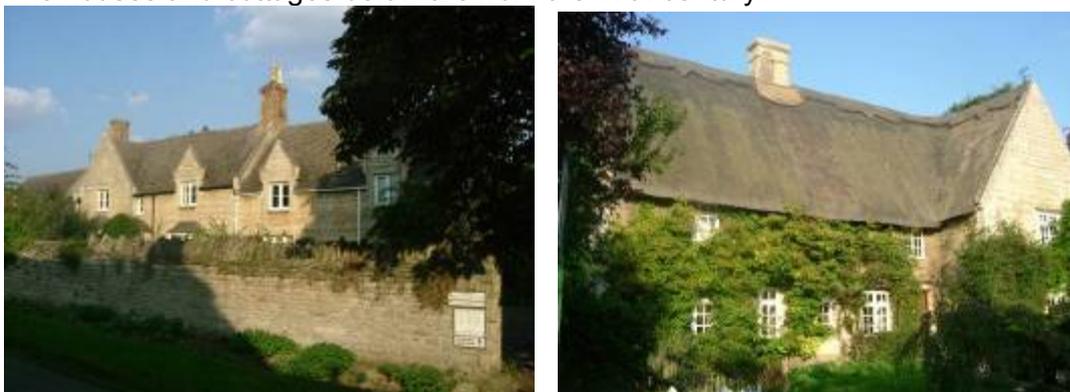
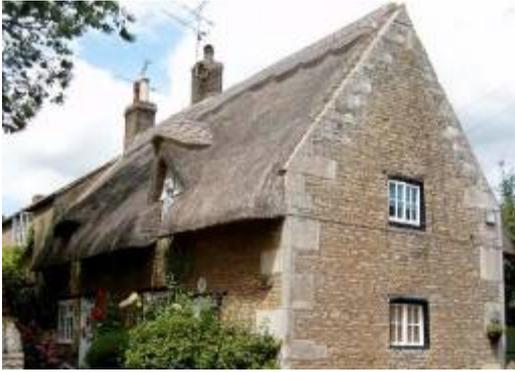
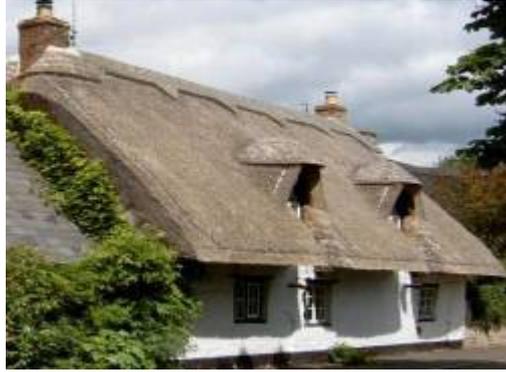
The houses and cottages below are from the 17th century

All are built in rubble with squared stone blocks for quoins, reveals and parapets. The houses are 2 storey and incorporate "L" plan forms. The cottages are one and a half storeys with a simple rectangular plan based on a front to rear wall span of about 6 metres.

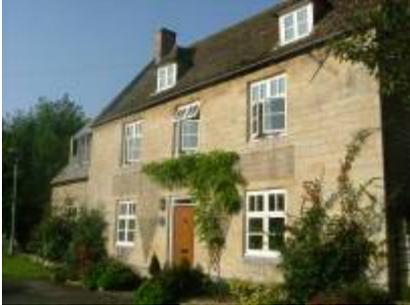
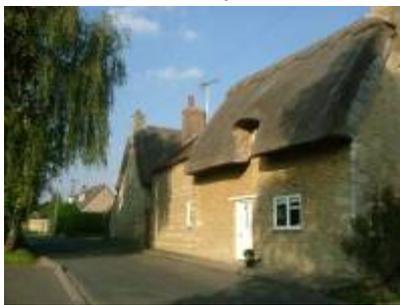
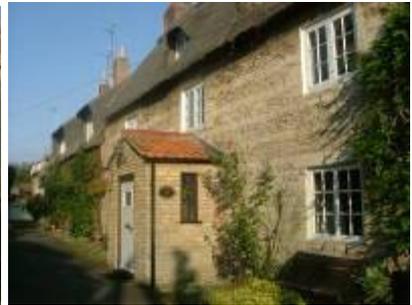
The properties below are all from the 18th century.

These maintain the architectural tradition of the late 17th century, with cottages of one and a half storeys with a narrow simple rectangular plan form. As typical of the Georgian period, the house is two and a half storeys, had a slightly wider plan form and included a small rear wing.

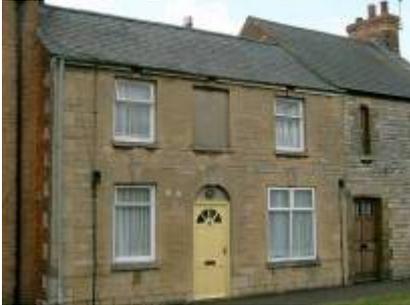
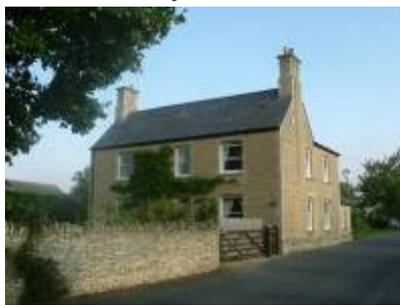
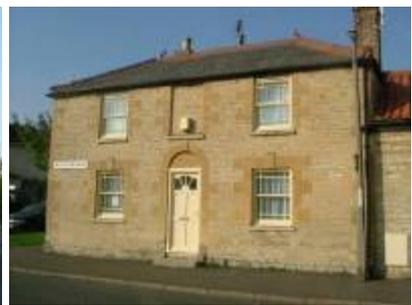
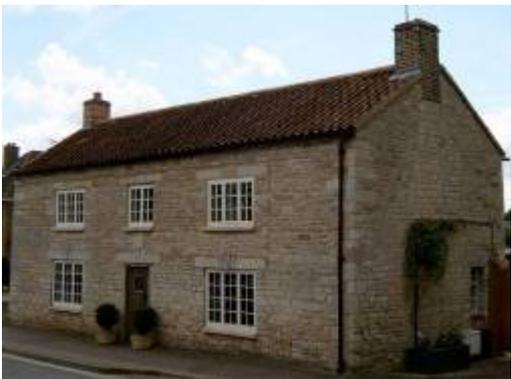
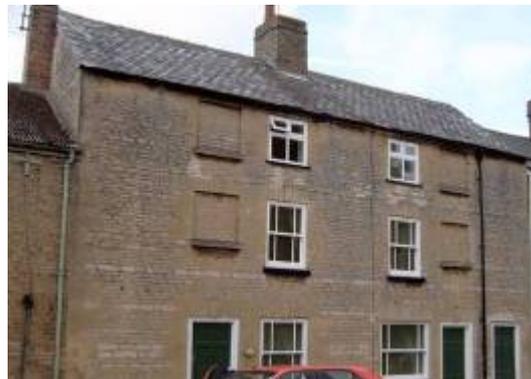
The buildings below are from the 19th century.

They are all of 2 or 3 storeys, rooms within the attics no longer being practical with the shallower pitch of Welsh slate covered roofs. The plan forms are rectangular but have become wider, accommodating 2 rooms within the width of the building.

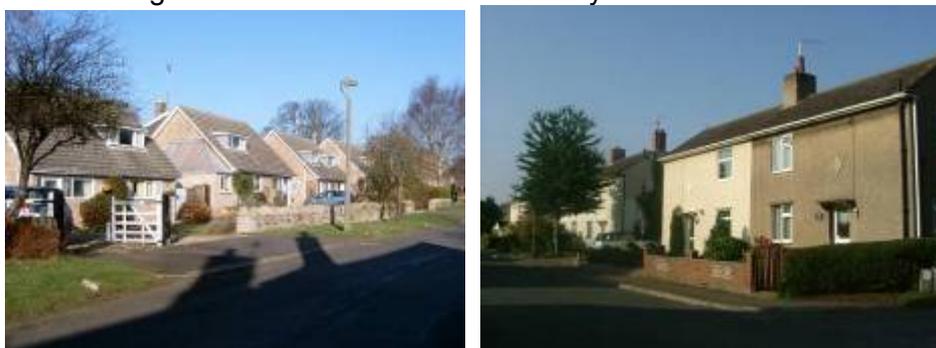
The buildings below are from the 20th century

They are typical of the 1960's / 1970's, being chalet in style based on a square to rectangular plan form and of 2 rooms deep.

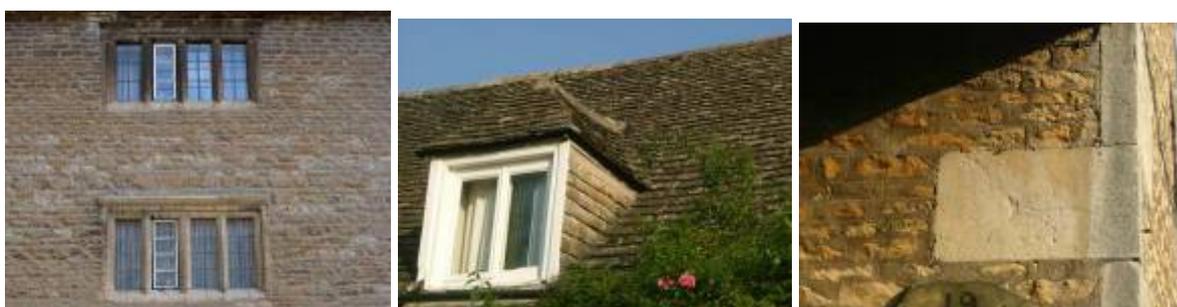
From at least Roman times, all formal buildings were constructed in local limestone, with carefully selected oak floor and roof structures. Windows were stone mullioned and roofs were in stone Collyweston slate. These materials and methods gave older buildings a longevity that has enabled them to survive to this day.

From the end of the 18th century single storey buildings were constructed as sheds and workshops in stone and timber, with roofs covered in stone slates or thatch. Clay pantiles began to be used from about the end of the 18th century with Welsh slates being increasingly imported with the coming of the railways. Most cottages had (and still have) long straw thatched roofs. Long straw is the stalks of the traditional species of wheat that was grown in the surrounding fields before short stemmed wheat was bred for combine harvesting. It was traditional for longstraw thatch to incorporate a simple 'swept' ridge (see photo page 8). The current use of decorative block-cut ridges did not appear until the latter half of the 20<sup>th</sup> century.

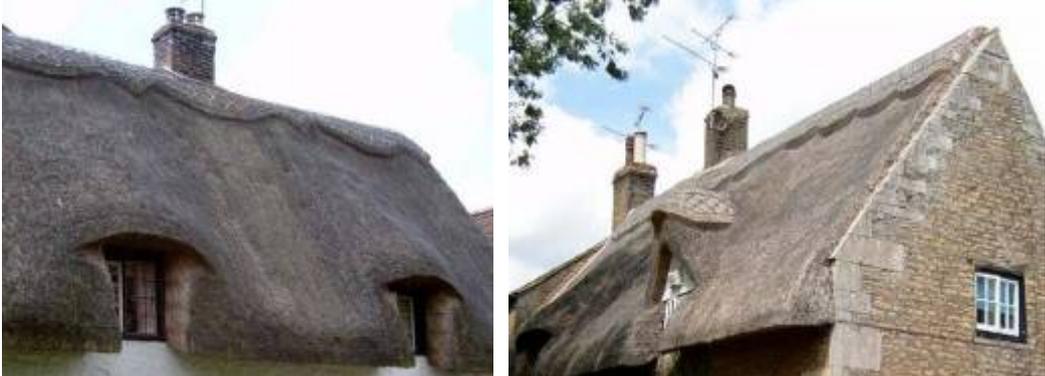
Typical 17th and 18th c. houses and cottages have

*Longstraw thatch roofs with hooded gabled or eyebrow dormers*

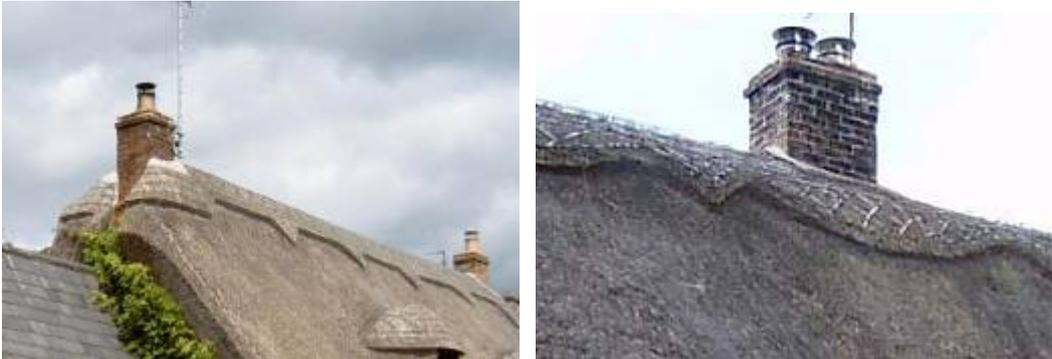
*17th c. chimneys are rectangular, set midway along the ridge.  
18th c. chimney stacks are usually square and built off the gable ends.*

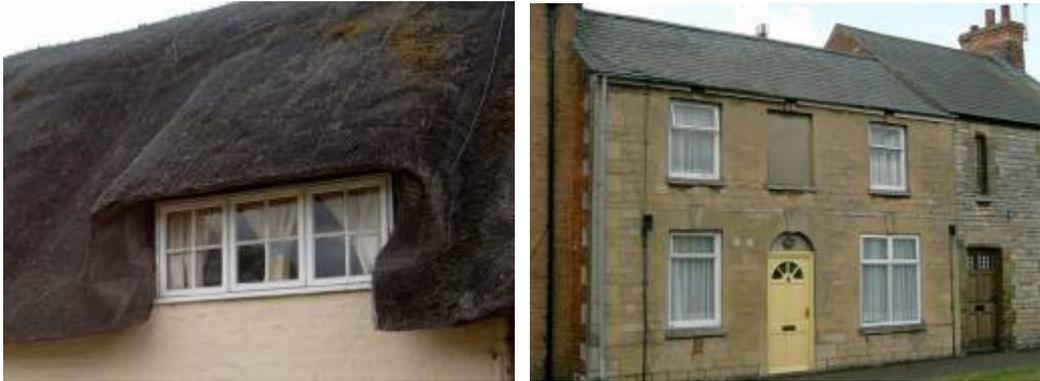
By the 18th c. wrought iron casements were incorporated into oak window frames. 19th c. cottage windows were in softwood, incorporating wood mullions and transoms. By the 18th c. better quality houses incorporated sash windows, and these evolved and continued to be used right through to the early years of the 20th century. Replacement uPVC windows almost always have a negative effect on the character and appearance of an older property and the conservation area. They do not achieve the visual quality of traditional windows due to the material and oversized frame elements

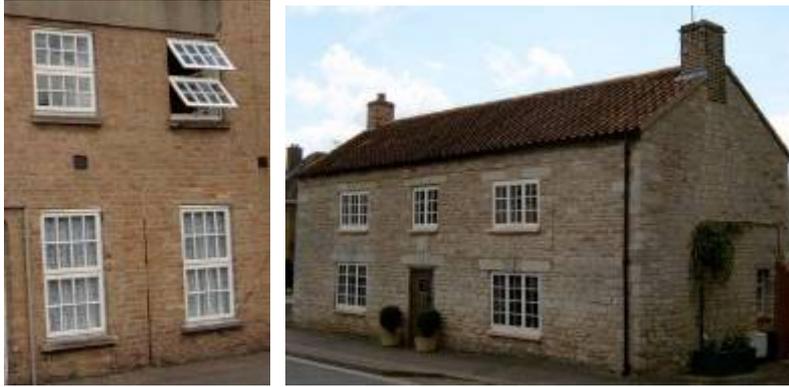
*20th c. sash and casement replacement windows.*

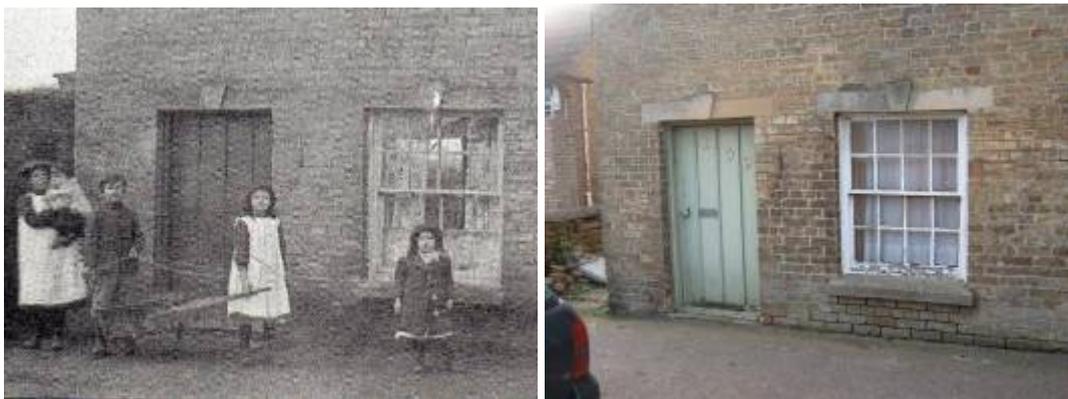
*19th c. beaded plank door and sash window - surviving to this day - 105 Peterborough Road*

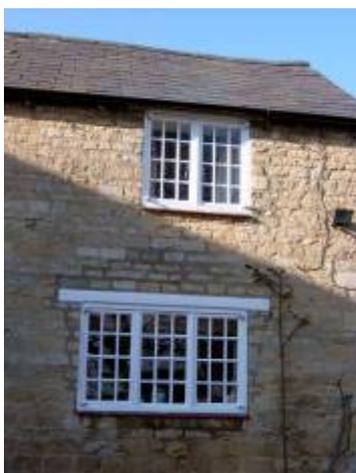
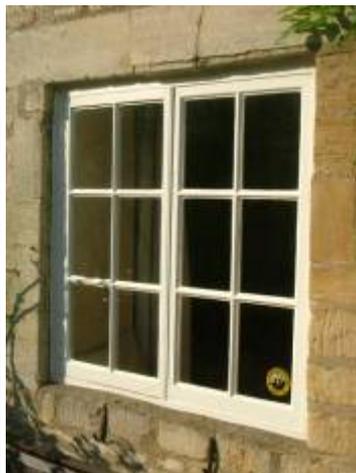
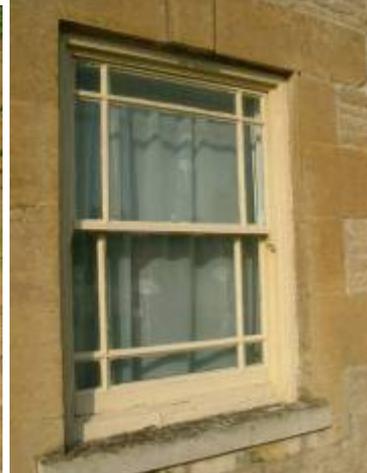
*19th c. casements*

*late 19th c sash*

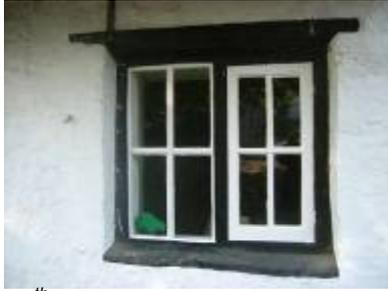
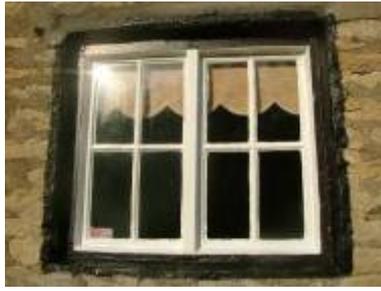
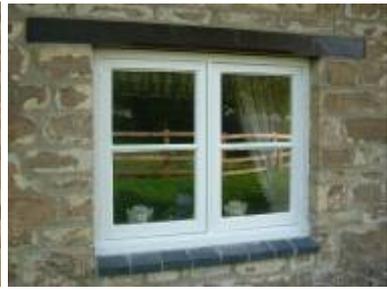
*19<sup>th</sup> c. casements*

*modern replacement casements*

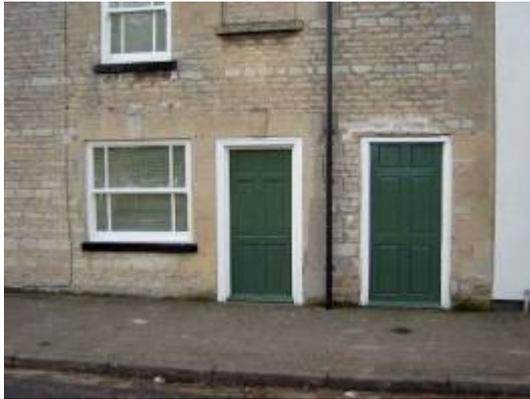
*19<sup>th</sup> c. doors & windows replaced in replica*

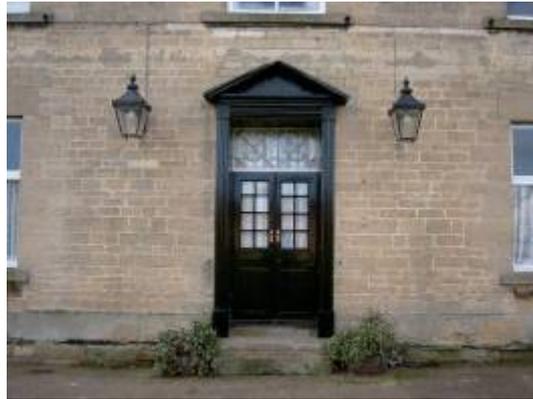
*19<sup>th</sup> c. door, fanlight and case, slightly modified in the 20<sup>th</sup> c.*

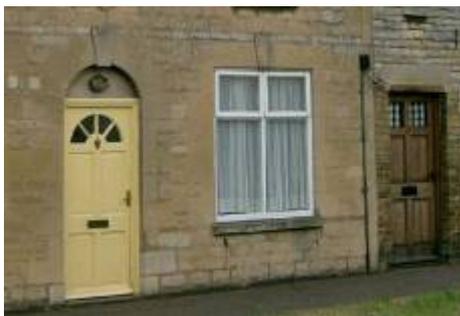
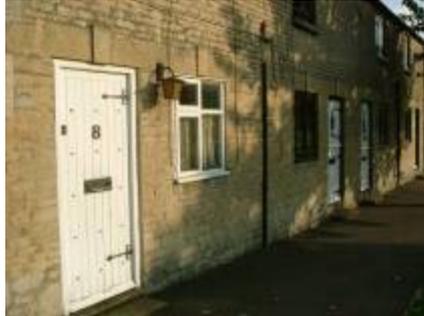
*Modern replacements of 19<sup>th</sup> c. sash windows, panel doors and 18<sup>th</sup> c. plank doors.*

Today, many pre- 20th century doors have been replaced with modern joinery. Some new doors are purpose made, others are standard joinery and frames, adapted to fit existing openings. In other cases, old openings have been adapted to accommodate the new joinery! A number of properties retain 19th c sash and casement windows.

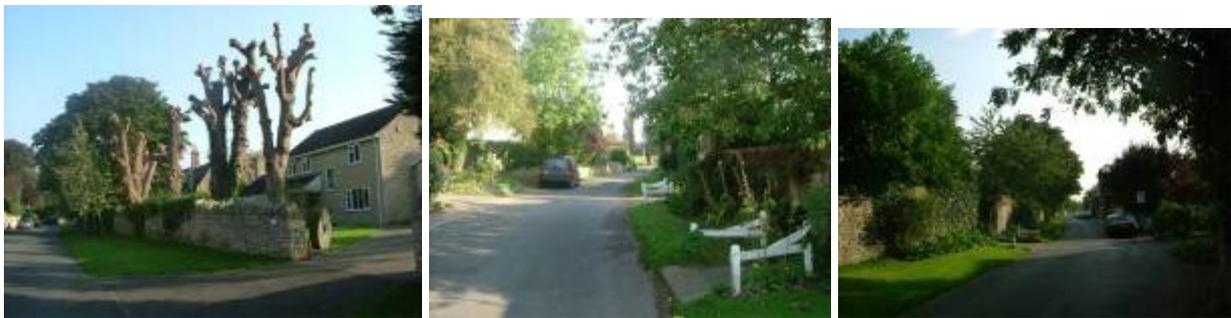
*Mature native trees make the greatest contribution to the street scene. Replacements need to be planted now to continue historic character into the future.*

Ornamental trees also have relatively short life spans in comparison with ash (250 - 300 years), lime (300 - 400 years) and oak (500+ years). Some strategic tree planting now of native species could help to maintain and enhance the character of the village and its setting in the long term.

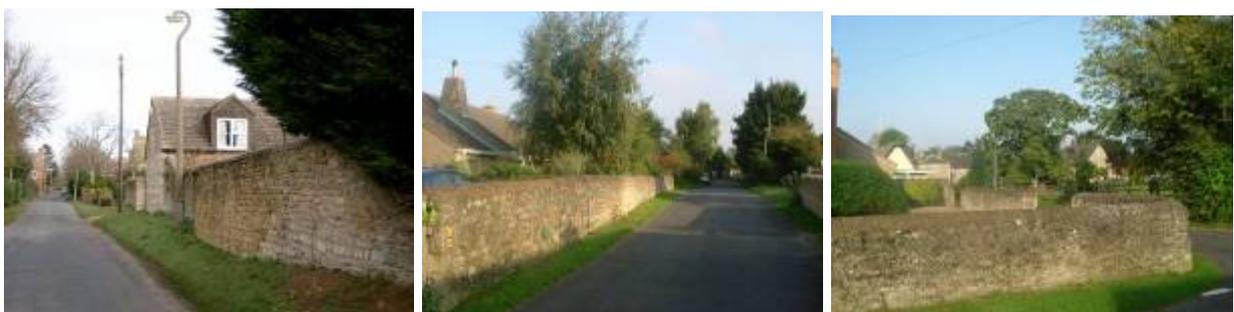
*Walls in the townscape*

There are several walls in poor condition; further loss of these important historic features would diminish the character and appearance of the conservation area. There may also be opportunities to construct new traditional walls, or restore the height of existing walls, as part of new development schemes. Further puncturing of walls through insertion of new drives should be avoided; if walls need to be dismantled to facilitate new construction they should be reinstated using traditional methods and materials, on completion of the works. The Built Environment Audit defines the most important traditional stone walls.

- **All existing stone walls should be retained, maintained and rebuilt if necessary and where there are opportunities (for example as part of a landscaping scheme or planning agreement linked to the grant of planning consent), restored to their original height.**
- **The City Council, in conjunction with the parish council, English Heritage and other bodies considers ways to assist the repair of existing walls and the building of new walls in the local tradition.**

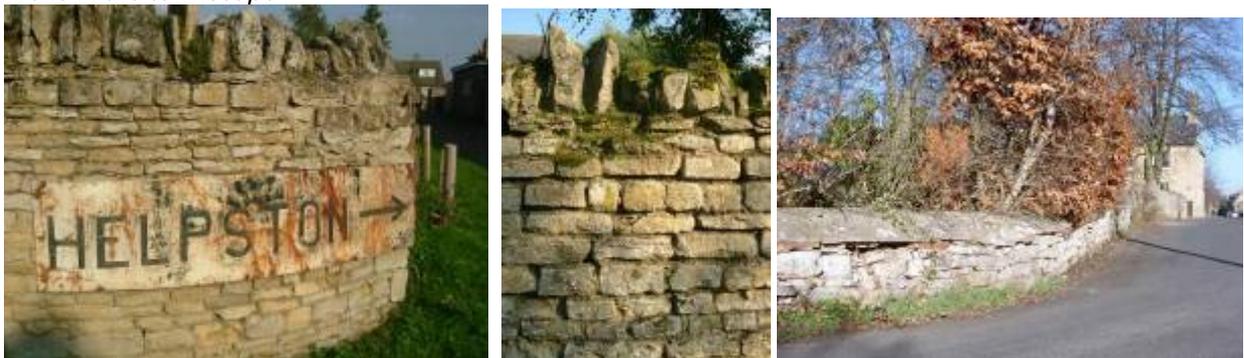
*Wall in poor repair*

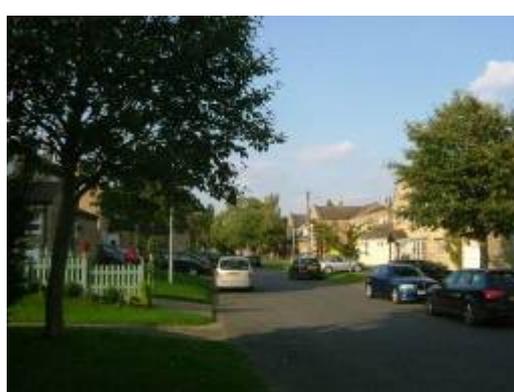
*Main Street 2008*

Until the first quarter of the 20th century, the village streets were narrow, with informal edges, meandering alignments and wide rough grass verges either side. As more properties have been built the increased volumes of traffic have gradually led to the formalisation of the highway and introduction of street furniture and signage.

During the 1960's and 1970's the streets were re-engineered to better accommodate motor vehicles and to incorporate mains water, electric and sewers; concrete and steel street lights, tarmac pavements etc. These works very much changed the character and appearance of the village. There are vestiges of earlier granite kerbs and local hard limestone setts but these are very much the exception. The number of items and the siting of street furniture could also be better planned. It is important to retain and encourage repair and reinstatement of the stone cobbles especially to the cuts running at right angles between Helpston Road and Main Street and Main Street and Maffit Road.

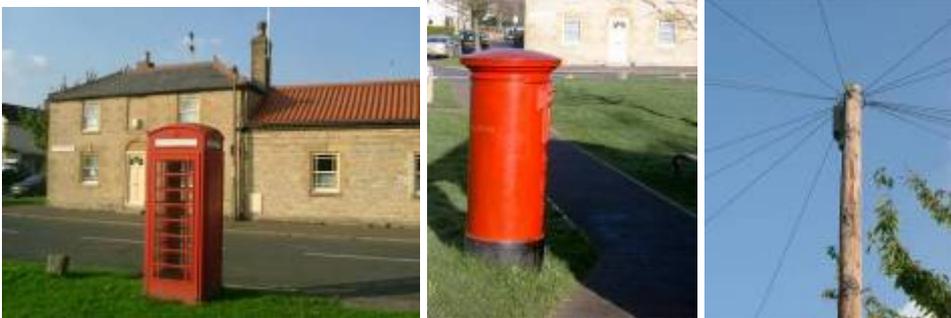
Some historic street furniture has been retained, notably, the K6 telephone box and letter box.

*K6 telephone box*

*post box*

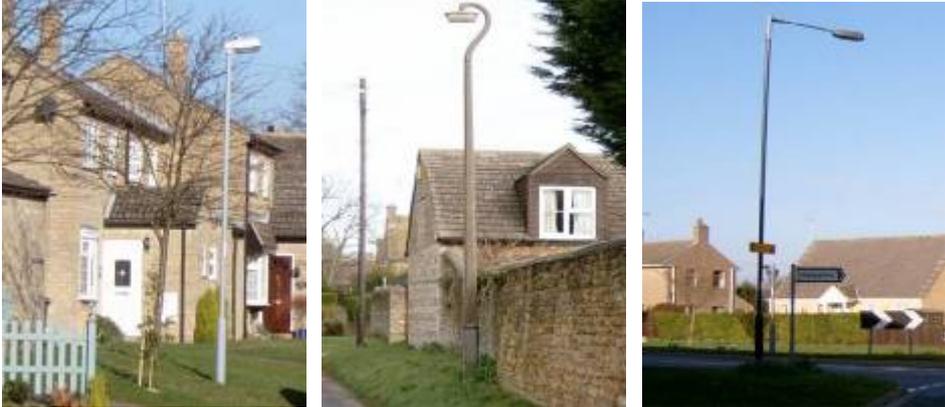
However, successive street works over the last 75 years have resulted in inconsistencies in other elements of street furniture; 3 different styles of lamp post in Main Street.

*Some of the styles of lamp-post in the conservation area.*

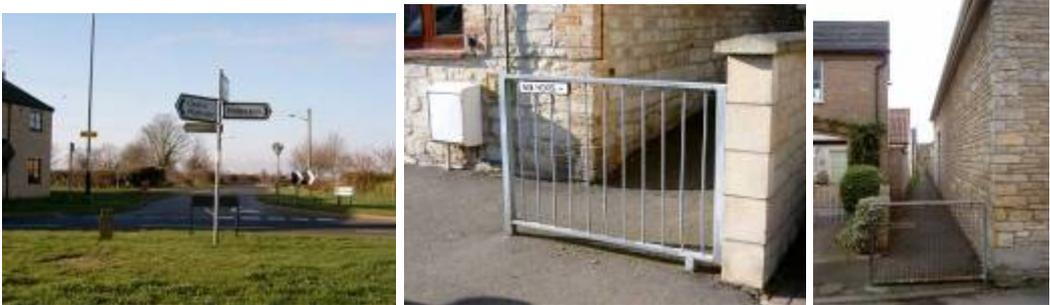
Around The Green there are a vast number of traffic, directional and other signs, street lights, litter bins, hydrant heads, and street name signs. This quantity and variety detracts from the appearance and sense of place in what should be the heart of the village.

*Street furniture - The Green*

*Modern utilitarian railings.*

- **As and when maintenance and repair works comes forward, the opportunity is taken to consider and rationalise signage and street furniture around The Green with a view to reducing and replacing existing elements with designs that are more appropriate to the heart of the conservation area.**

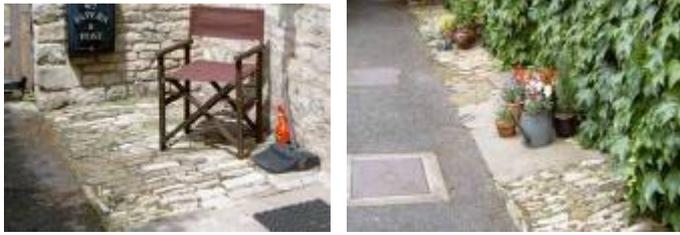
*Historic floorscape in local limestone setts*

There are remains of traditional paving and, where reasonably continuous, these are an attractive and historic feature of the conservation area. This type of paving employs particularly hard locally quarried limestone, sometimes known as Wittering Pendle, shaped into setts and laid on edge.

- **As proposals come forward to repair and maintain the cross paths and similar surfaces, opportunities are taken to reinstate traditional surfacing and in particular the local stone setts, fragments of which still survive.**

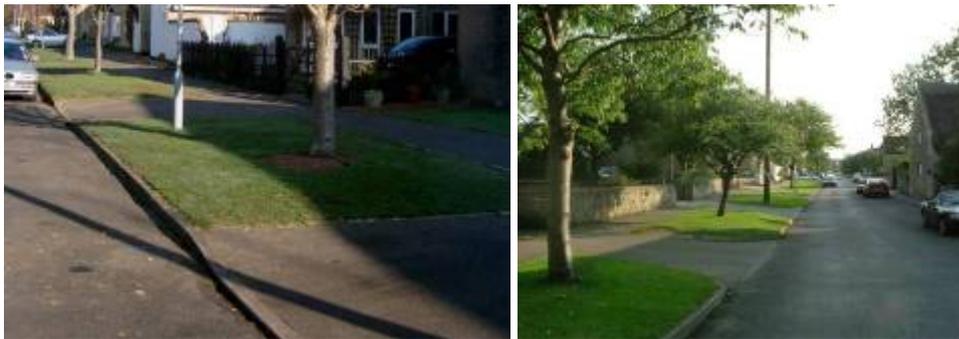
*Sub-divided grass verge*

The infilling of frontages has meant that the once continuous grass verges have been sub-divided by drives and drop kerbs. This changes the character of the village.

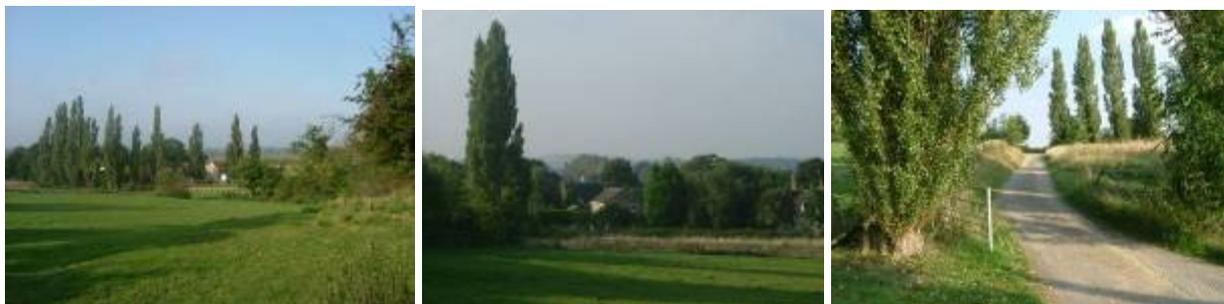
The effect of designation would assist in the retention of trees, hedges and track alignments and may encourage positive actions for the sensitive management of this relatively small but important area of historic landscape.

*Land to the north of the village*

- **Extend the conservation area boundary to the north as indicated on the proposals map (Appendix 1).**

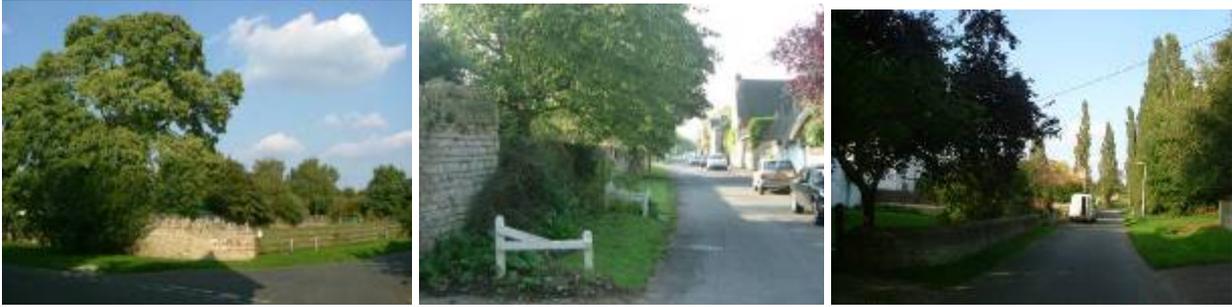
The character of the village is changing as more trees and hedges are planted in front gardens and on the grass verges. At the same time, the large native trees, known to exist in the 1880's have been lost or are nearing over-maturity, and specific provision should be made to gradually replace these. It is accepted that this process has begun with, for example, the planting of oak saplings on the paddock frontage between Main Street and Helpston Road. In contrast to the native forest tree species, the ornamental species do not have the same character. Many of the ornamental trees planted within the verges have comparatively short life-spans and it can be seen that many will require arboricultural work/removal in the foreseeable future.

*Mature native trees greatly contribute to townscape character, but planned replacements are needed.*

To retain and enhance Ailsworths character care is needed in the siting of new planting and selection of species. The most effective planting is often where trees are positioned directly opposite gable ends of buildings close to the pavement. The combination of the mature tree and gable then form a "gateway" from one part of the street to the next and giving different parts of the streets their own character and sense of place.
